**MICROCHIP**

**PIC18F6627/6722/8627/8722**

**PIC18F6627/6722/8627/8722 Rev. A1 Silicon Errata**

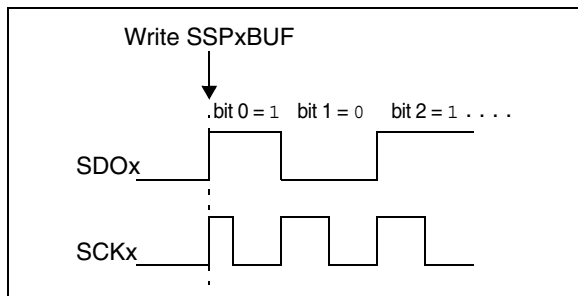
**FIGURE 1: SCKx PULSE VARIATION USING TIMER2/2**

## 21. Module: MSSP (SPI Mode)

When the SPI is using Timer2/2 as the clock source, a shorter than expected SCKx pulse may occur on the first bit of the transmitted/received data (Figure 1).

### Work around

To avoid producing the short pulse, turn off Timer2 and clear the TMR2 register, load the SSPxBUF with the data to transmit and then turn Timer2 back on. Refer to Example 4 for sample code.
